# Repairing the KWS-1 Plate & Ant Loading Controls

- WBear2GCR © 2018

The Collins KWS-1 Plate & Antenna loading controls frequently bind up and/or fail to run smoothly. The causes of this problem are found, discussed, and solutions presented. (more pictures still to come)

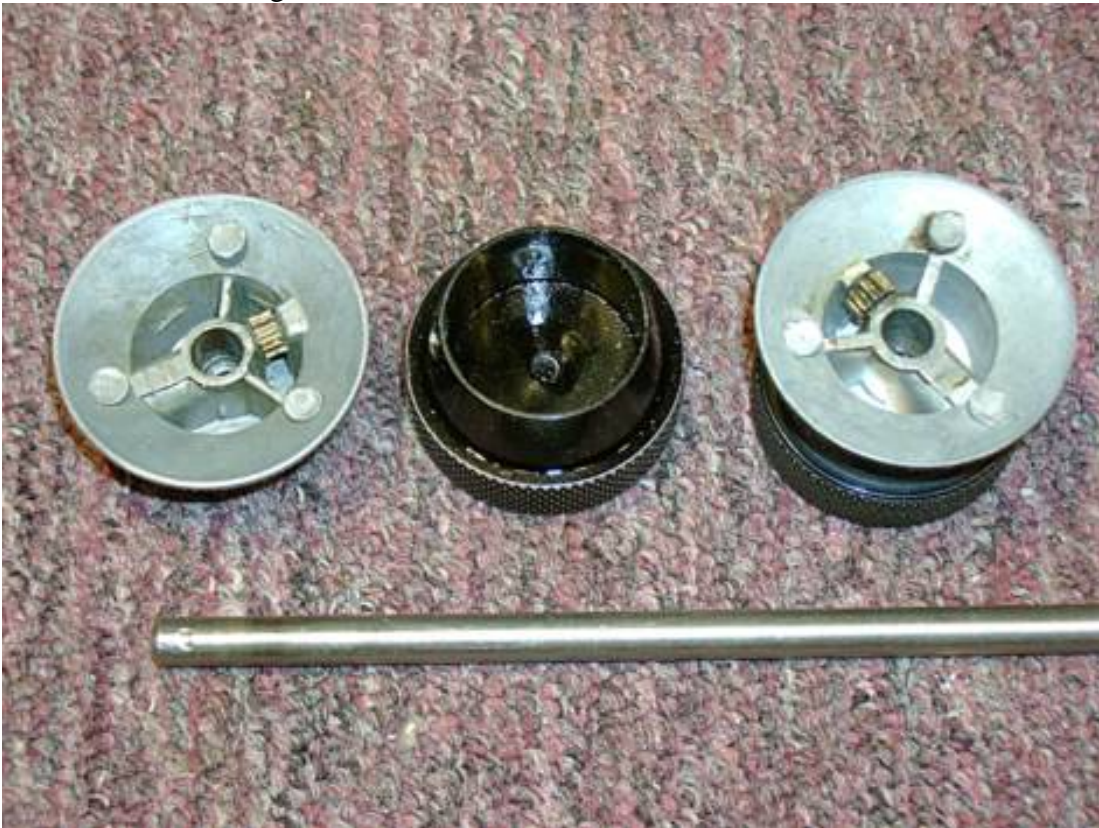
What happens is that over time the 0.250" hole in the knob that fits the stainless steel shaft becomes *elliptical*. This happens because it was made of cast *potmetal*. Potmetal is malleable (before it just breaks) and after time and under the pressure of the setscrew and use it will not keep its shape. This hole has not kept its shape.

I've measured a few. They vary a bit. One measured 0.264" in one direction (on the axis of the set screw!) and 0.254" in the other. All measured "over" by a significant amount.

The knob disassembled. Note the right most knob has a thicker wall and is faced down (from the factory) more than the left knob. Both were spread and out of round. The 6-32 screw hole is barely visible left knob, and can be seen in the center of the Collins anodized aluminum upper knob (center).

To remove the Collins machined aluminum upper knob section from the Helipot knob (which has the skirt) what I have done is to put a few drops of penetrating oil on the junction of the machined upper knob section and the skirt. Also *remove* the connecting screw from the knob. Put some drops in there. Let sit. This screw sits in the hole at the

end of the 1/4" shaft hole. Remove this screw first. Place a *long* 6-32 screw into that threaded hole. The long 6-32 should reach above the level of the skirt, tighten it just firmly hand tight. Hold the skirt in your hand, and with a small hammer tap lightly on the screw - the upper knob will pop out after a few taps. No need for a vice.

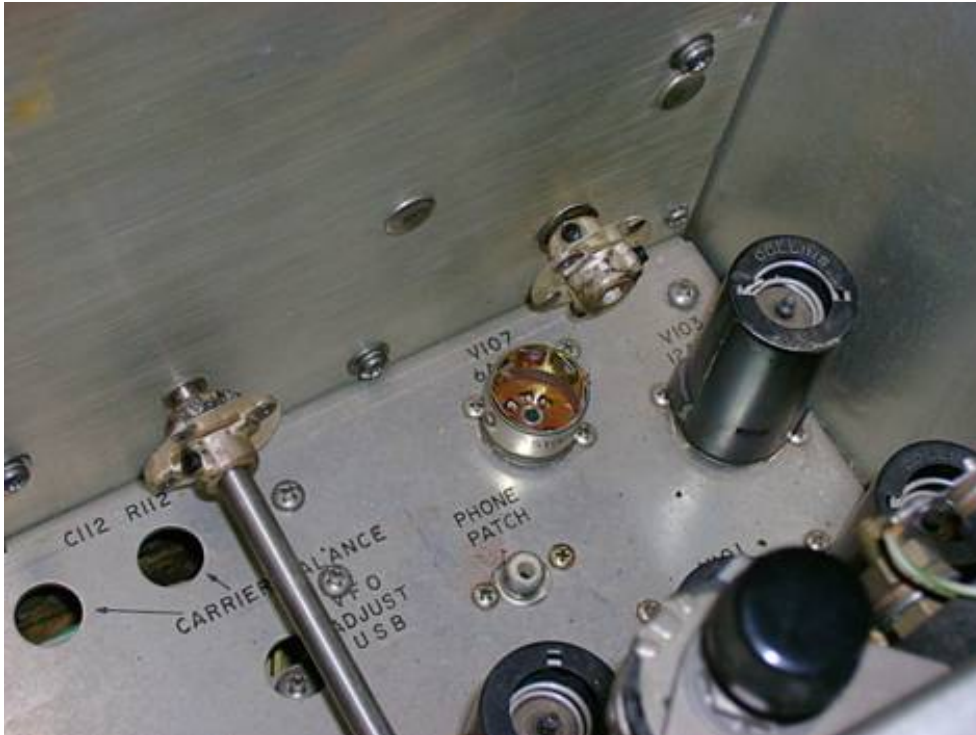
There is another problem. The shaft that Collins provided (at least in this early KWS-1) is short. By short I mean that it does not reach fully to the rear of the hole in the knob. This is bad considering that we're talking a cast potmetal knob. All the force is on a short section of shaft, at the front of the knob hole. It would improve matters to spread the force along the full depth of the hole. SO, the shaft ought to be extended by about 0.20" to 0.25" in length. Then it will reach to the back of the hole.

The shafts coming through the PA section with the stock couplers

How to extend the shaft length? There are two possibilities. A) move the shaft out, by loosening the shaft coupler set screws, and the shaft collar and sliding the shaft outwards, or B) fabricate a new shaft.

Now, (A) will *not work* because there is insufficient "meat" available inside the stock shaft coupler. What to do? Change shaft couplers! You'll need a longer shaft coupler (one for each control) one that permits about 1/4" at minimum additional distance from the PA cage input shaft(s). Those PA input shafts are "shorty" as well. It **MUST** be a flexible shaft coupling. Watch the coupling's diameter so it is sure to clear the nearby tube (6AK5) (only for the ANT TUNING control shaft).

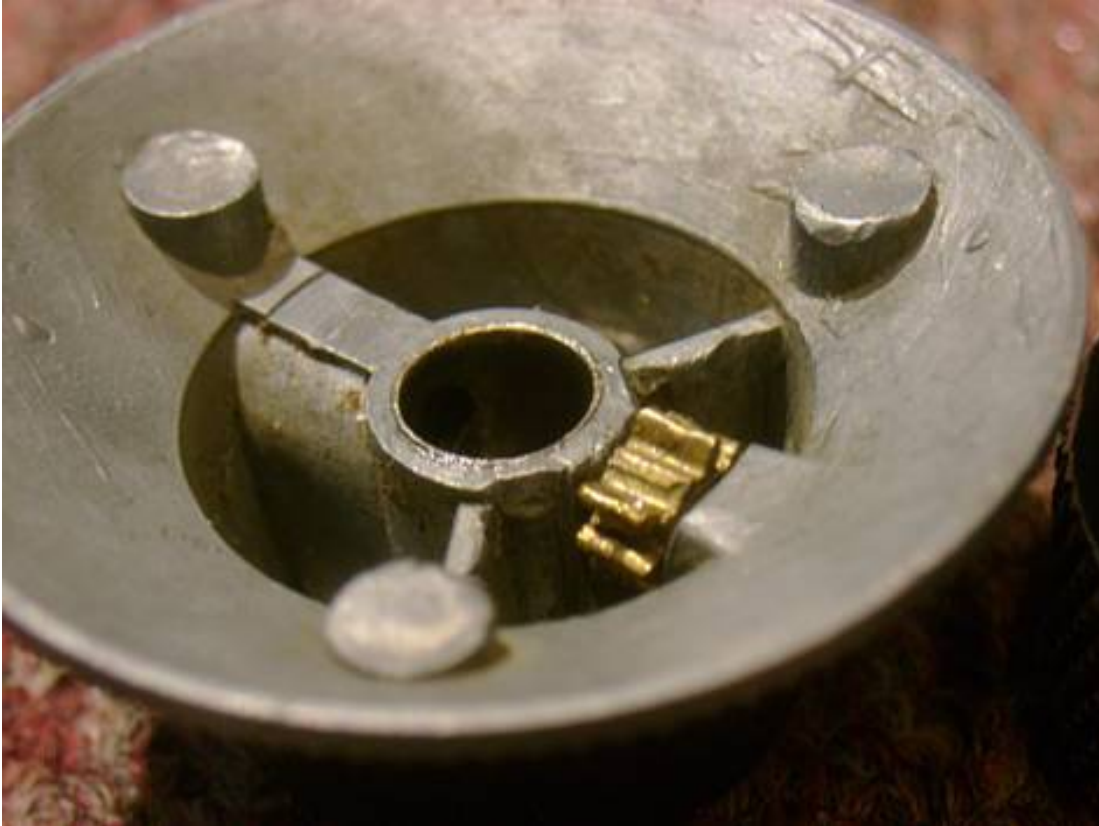
Note the worn edges, this knob it turns out had a brass insert! Note the broken brass tooth!

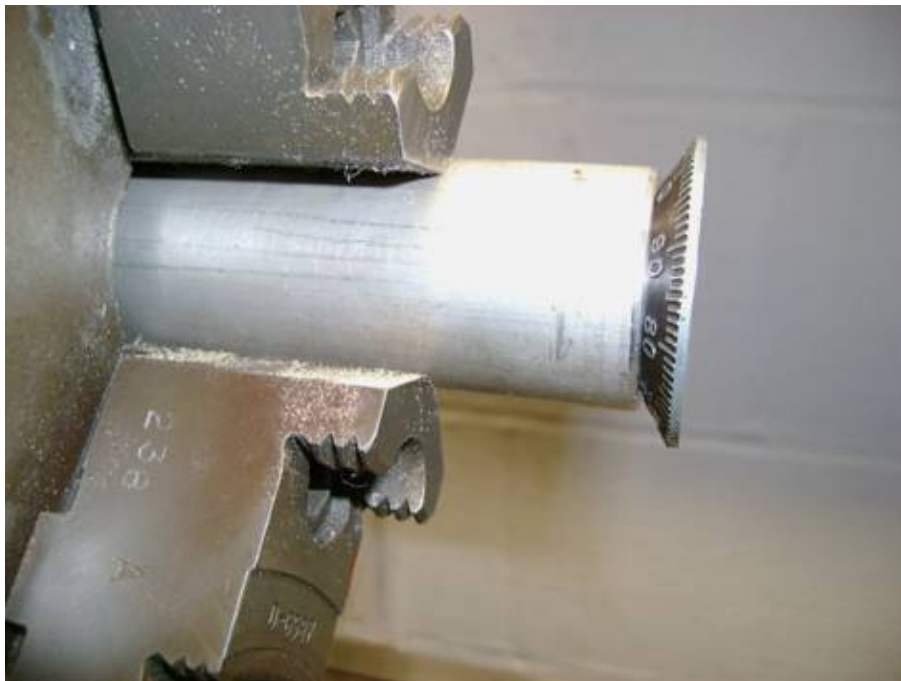
This is the knob holding fixture I made from 1.250 aluminum bar stock, drilled, and then lightly bored to mate tightly with the outermost edge of the inner knob. The knob is held by a 6-32 screw that like the Collins assembly goes up through the top of the knob - the fixture is tapped to accept the screw.

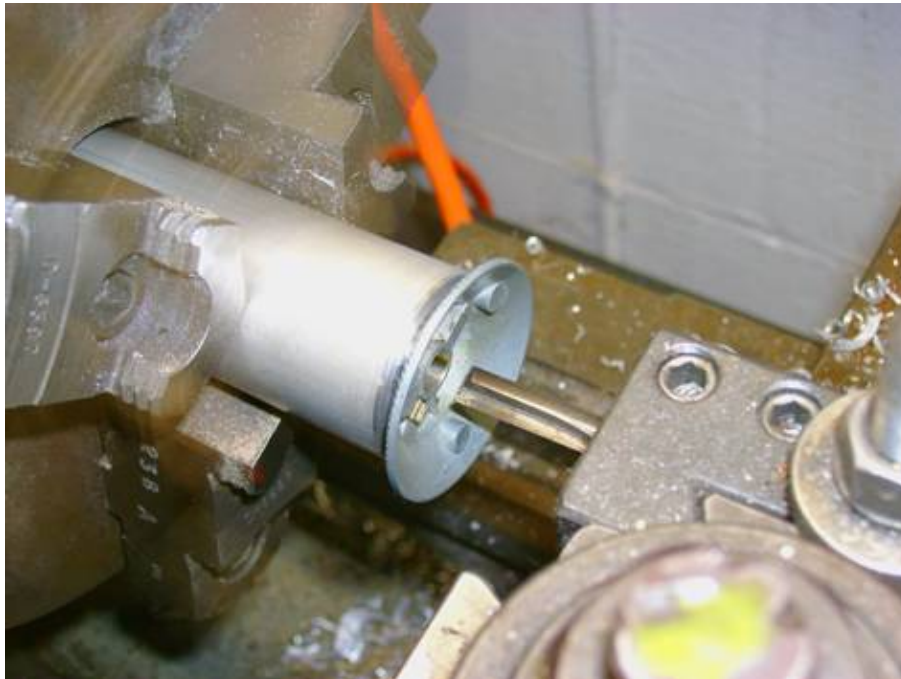
Here the bore is being lightly cut on the lathe. Note the bright brass color, this knob had an insert made and inserted by a previous owner to try to save the knob. It did not last.

The main trick here is to get the shaft and the knob properly aligned. Super simple with a lathe. But the idea remains constant. The shaft must go as far as possible into the knob, where there is no wear, so that it is centered - then the only thing that is required is for the skirt to end up perpendicular to the shaft. A machinist's vise or some other solid fixture that will maintain the proper perpendicular relationship between the shaft and the knob will be sufficient. What I am saying here is that by using the unworn part of the knob, this will assure centering, while a machinist's vice (etc) will maintain perpendicularity)

Using the lathe for alignment, and bonding, boring is not even required.

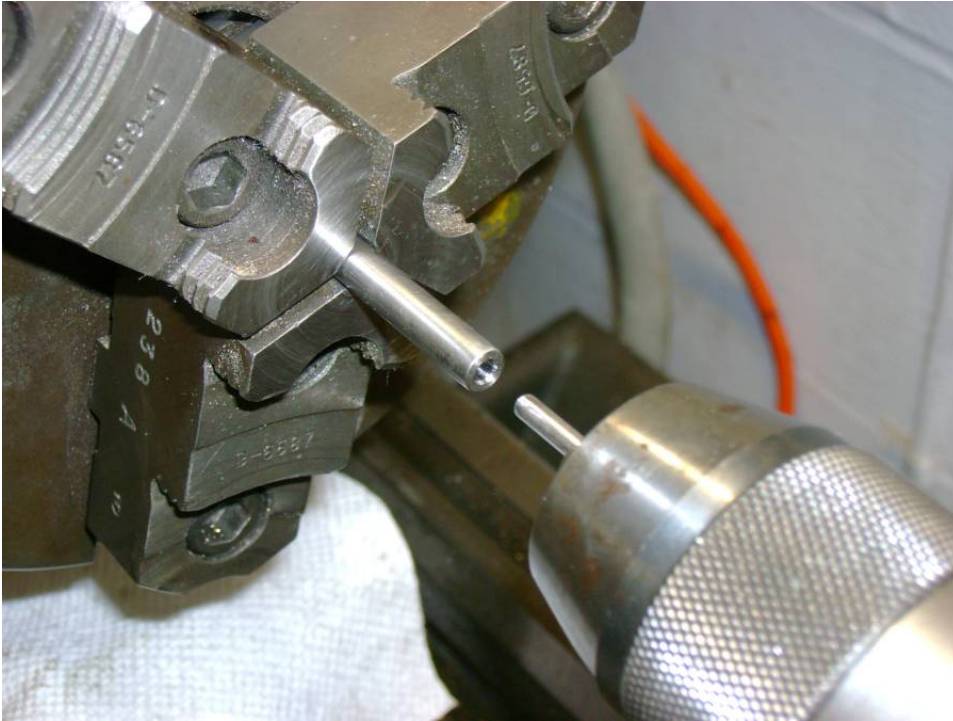
The 0.125" rod has been cut to length, polished and finished. The hole has been drilled deeper than needed. The tailstock of the lathe slides the two together and holds them in alignment. Anaerobic shaft locker is first placed on the mating surfaces prior to assembly (not shown).

Here's how I fabricated the shaft - two parts. It was easier to drill the 0.250" shaft than to machine it precisely down to 0.125". Easier and faster by far. I used some 0.125" rod and some 0.250" rod, drilled the end of the larger, and used anaerobic "shaft locker" to bond them permanently.

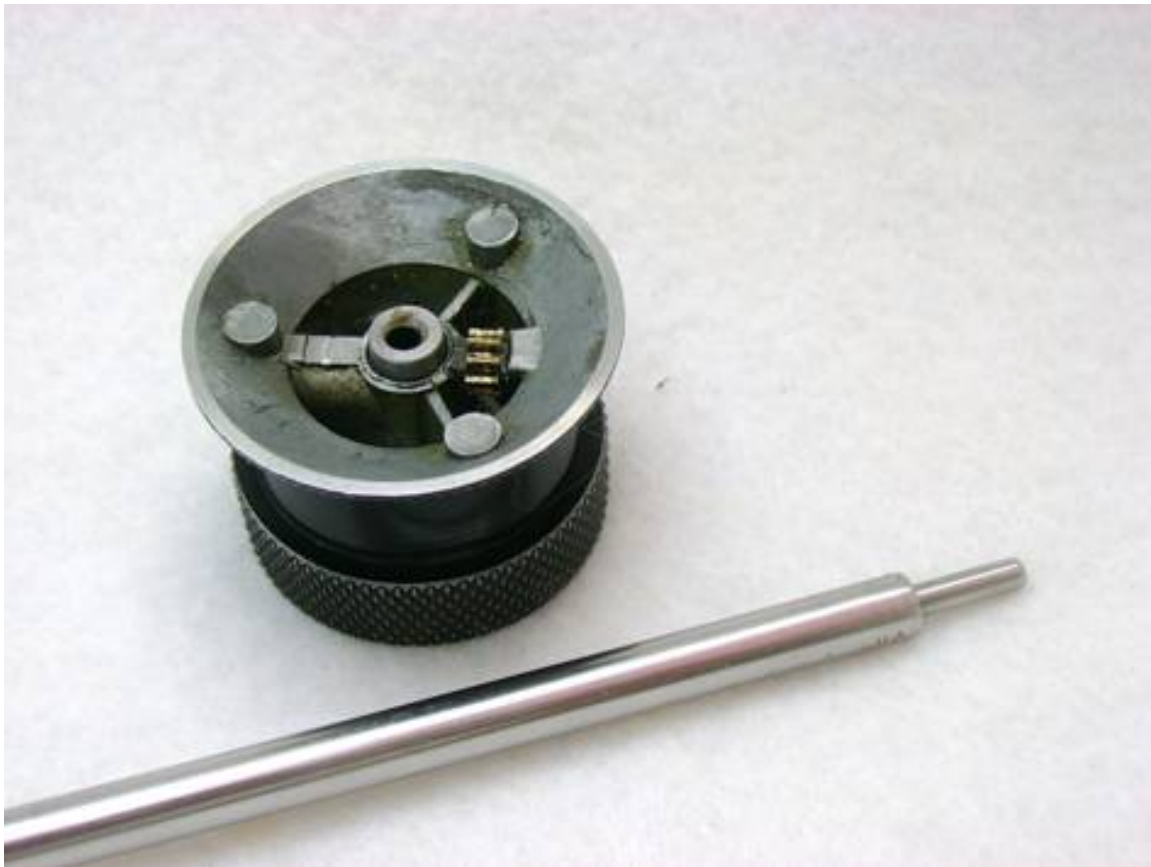
The knob and shaft. The insert stands proud of the potmetal hole for added strength. The hole is 0.125" and the shaft end is polished to make a slide-in fit. The insert was aligned in the bored hole using the shaft held in the tailstock, and after anaerobic shaft locker was applied, the insert, sitting on the shaft was slid into place and left to set-up.

After trying several shafts and materials, I realized that for the repair to work, the issue was going to be the pressure of the setscrew against the shaft, pushing on the opposite wall of the knob's hole. No good, that's what caused the knob to bell originally. So, my solution was to make a steel insert that uses a 0.125" shaft hole, rather than the full 0.250" shaft hole that the knob usually uses. This way the setscrew can "grab" a few turns of the insert. In this way the force is now transferred to steel, rather than the potmetal. Doing this ought to keep the knob from being distorted.

The hole in the knob itself was machined round and then measured. A custom steel insert was made with an 0.125" hole bored to fit the ID of the hole in the knob. Another hole was drilled to meet the setscrew hole. This hole was made undersize by a bit to permit both easy alignment with the setscrew hole and for a cutting tap and then a plug tap to be run through, *after* the insert was bonded in place. This allowed the setscrew to "grab" a few turns in the steel insert.

*The benefit of doing this is that now the force is across the steel insert, not between the potmetal setscrew hole and the opposite side of the hole - insert in place or not!*

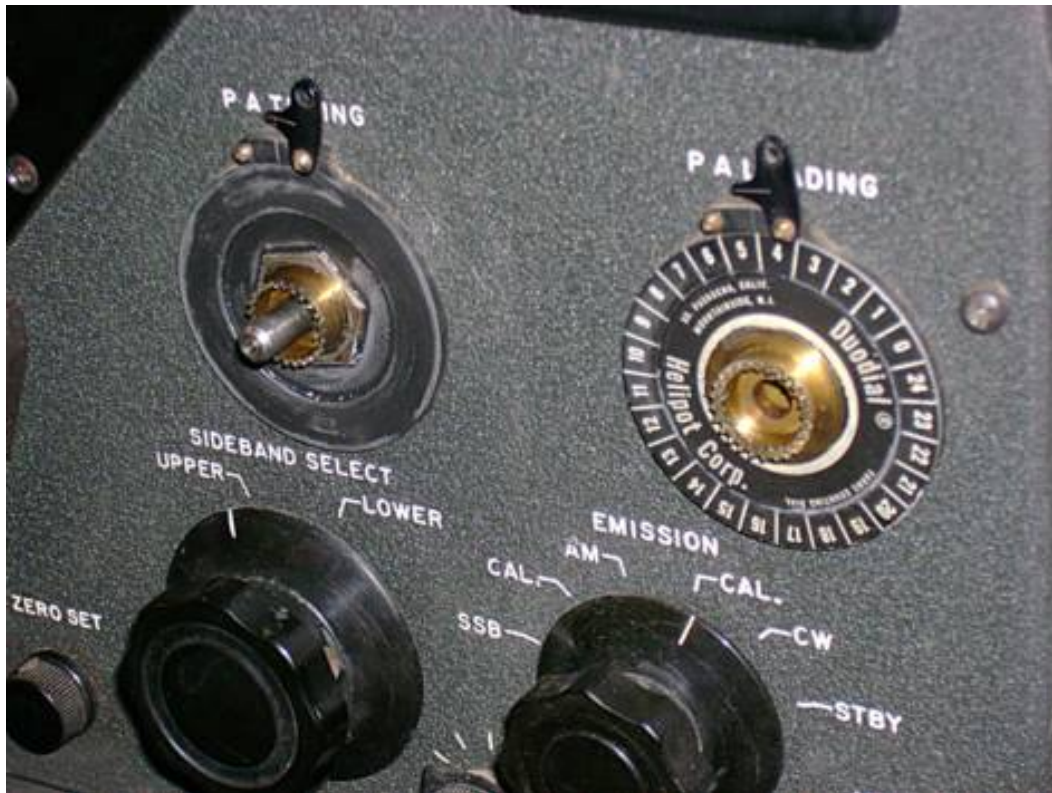
The front panel's Helipot indicators. One still installed, and one removed. There must be no burrs on the inner toothed gear's mounting nut. A thin layer of silicone grease on the plastic will likely aid smoothness, once the knobs themselves are repaired. The indicator below has been re-glued some time ago.

I chose to use all synthetic lube for the re-installation. Silicone grease, synthetic gear oil (automotive 50w), and "shock oil" for RC cars (comes in weights from 10w up into nearly grease), as well as standard synthetic motor oil are all candidates. The advantage over the stock grease is that these will never harden or gum up. I suggest the silicone grease for the area behind the outer counter ring that rides over the black rear piece. Between the inside bushing and the outer counter ring, either the grease or one of the heavier lubes seems like the right idea. Some sort of grease ought to be over the area where the gears of the counter and the gear in the knob contact. There needs to be some lube for the brass gear's shaft in the knob too. That ought to be a lighter oil. I'd suggest a removal and re-inspection after some time in service to observe that the lubes are still in place and working.
