Vialiant Speech Amplifier

Voltage and Current Readings at Keydown

Parts Replacement List

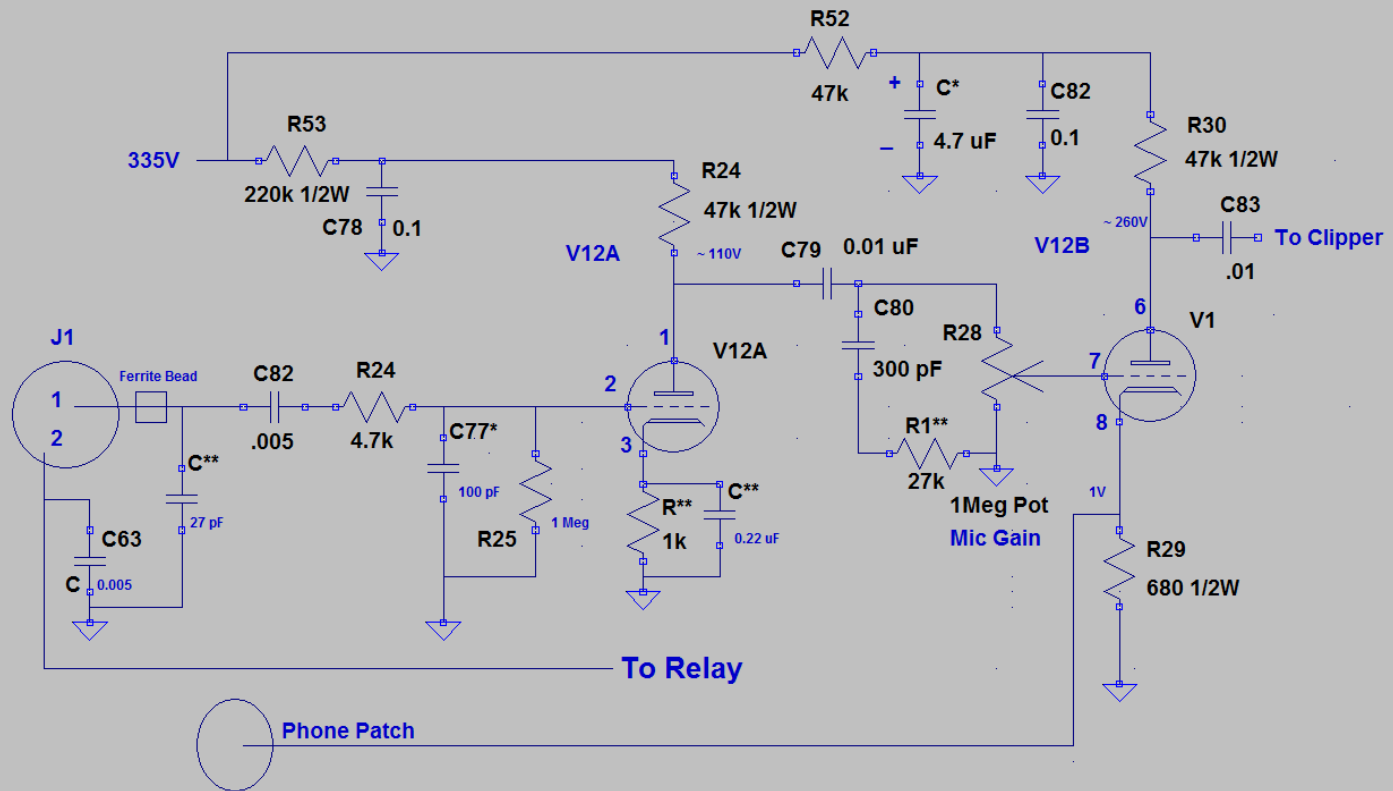
10. The audio was checked with a dynamic microphone of 50k Ω microphone impedance. Any microphone with an impedance of 50k Ω or above, such as a D-104, will drive the Speech Amplifier. Set Clipper initially to 12:00 O'clock and work from this setting. Don't use too much clipping or distortion will occur.

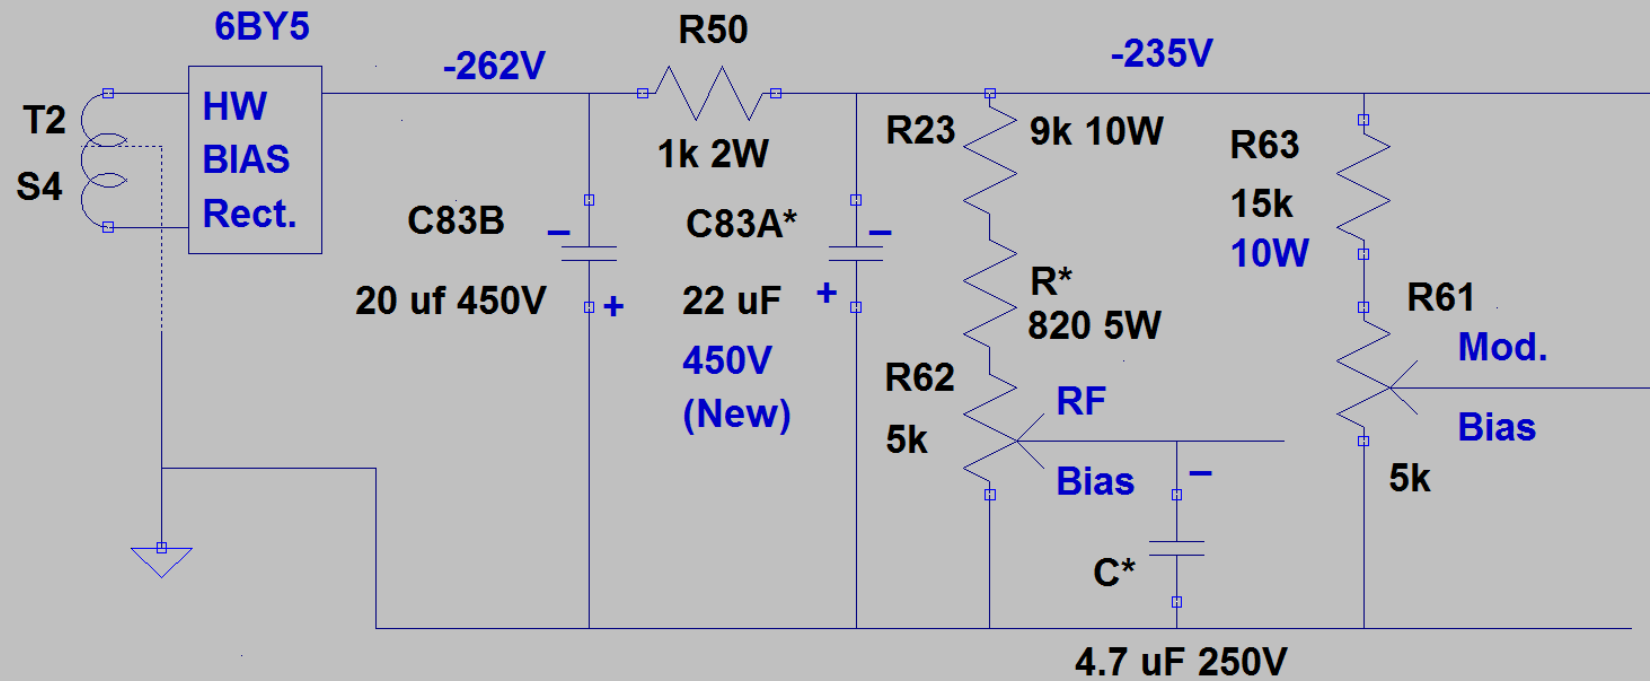
Valiant BIAS PS

Final Grid Voltage **Bias** at bottom of R57: -70V

6. The RF and Mod bias voltages were set to accommodate the higher 120VAC powerline voltages. Someone put epoxy adhesive on these pots. This is stupid since anytime different tubes are installed, these pots must be adjusted. Only a mild Loctite adhesive should be applied

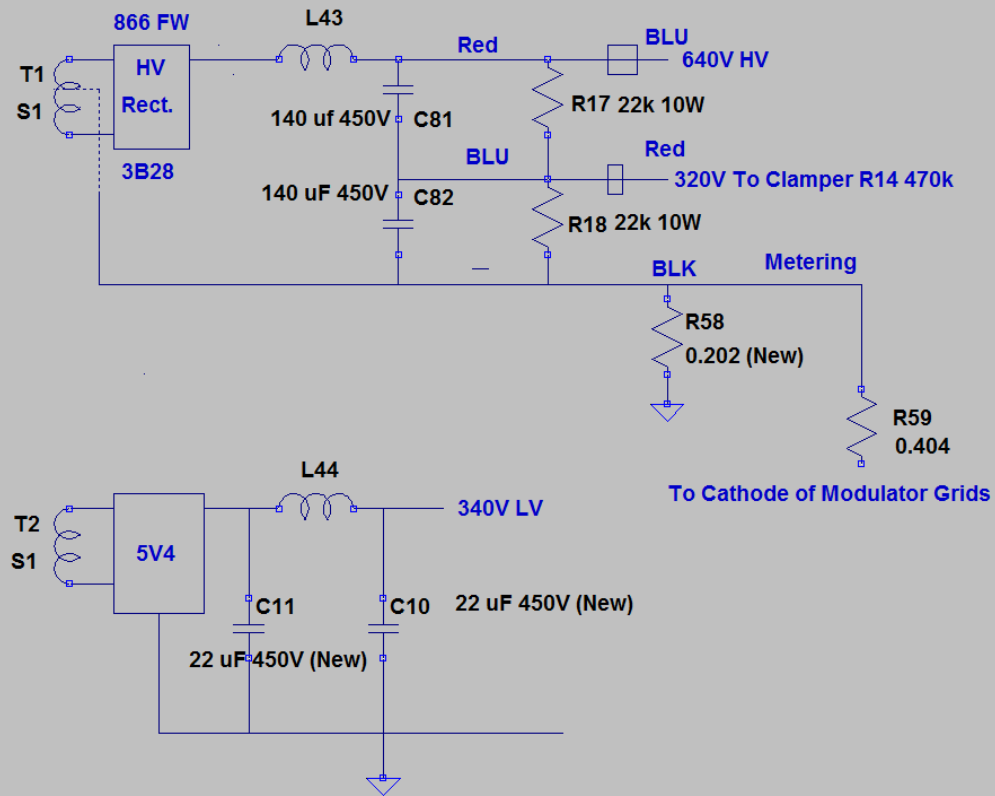
Valiant HV and LV PS

HV: 650V

LV: 340V
