Kenwood TS-930S Repair

Problems:

Primary Issue: The radio was not producing output. Specifically, it was producing very low output, on the order of 2-5 watts. The radio had previously produced full output.

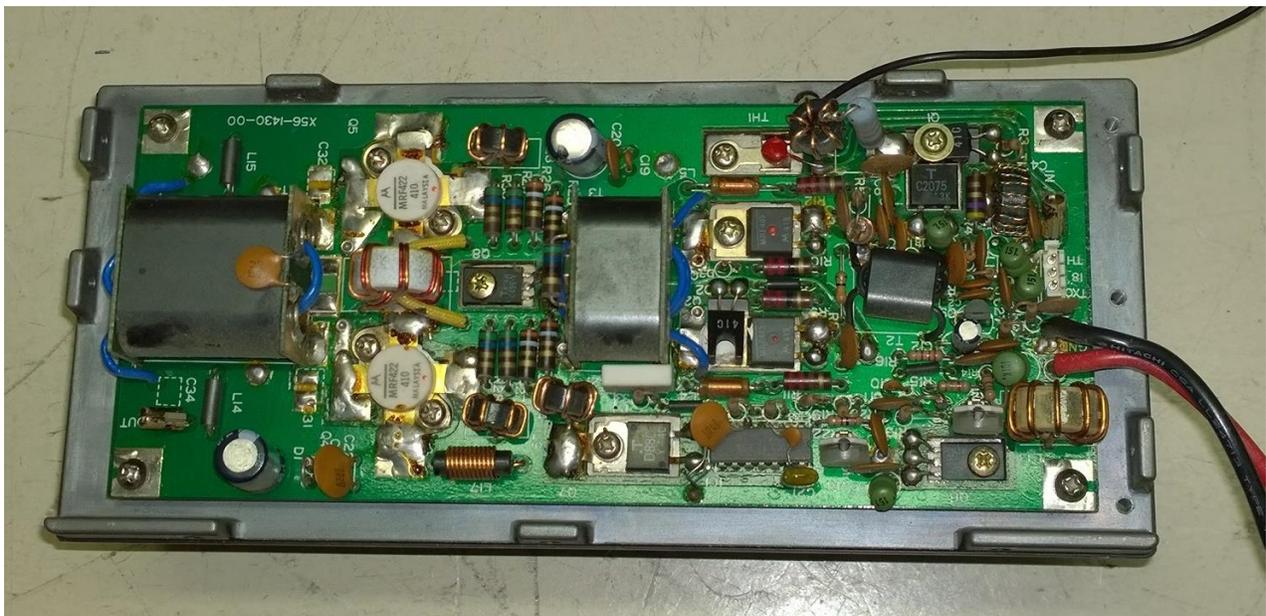
The panel meter and a digital multimeter showed normal voltage (Vc) of 28.5 volts, suggesting that the problem was in the Power Amplifier (PA), so I pulled the PA. I immediately noticed that the PA was an OEM unit with the desirable low-gain OEM Motorola “Red Dot” MRF485 drivers.

Resistance and diode tests showed that the Drivers and Finals were good, so I put the PA in my good, working 930S. It performed perfectly, producing full output. To protect this OEM PA, I replaced it with one of my rebuilt ones for the remainder of my testing and repair work.

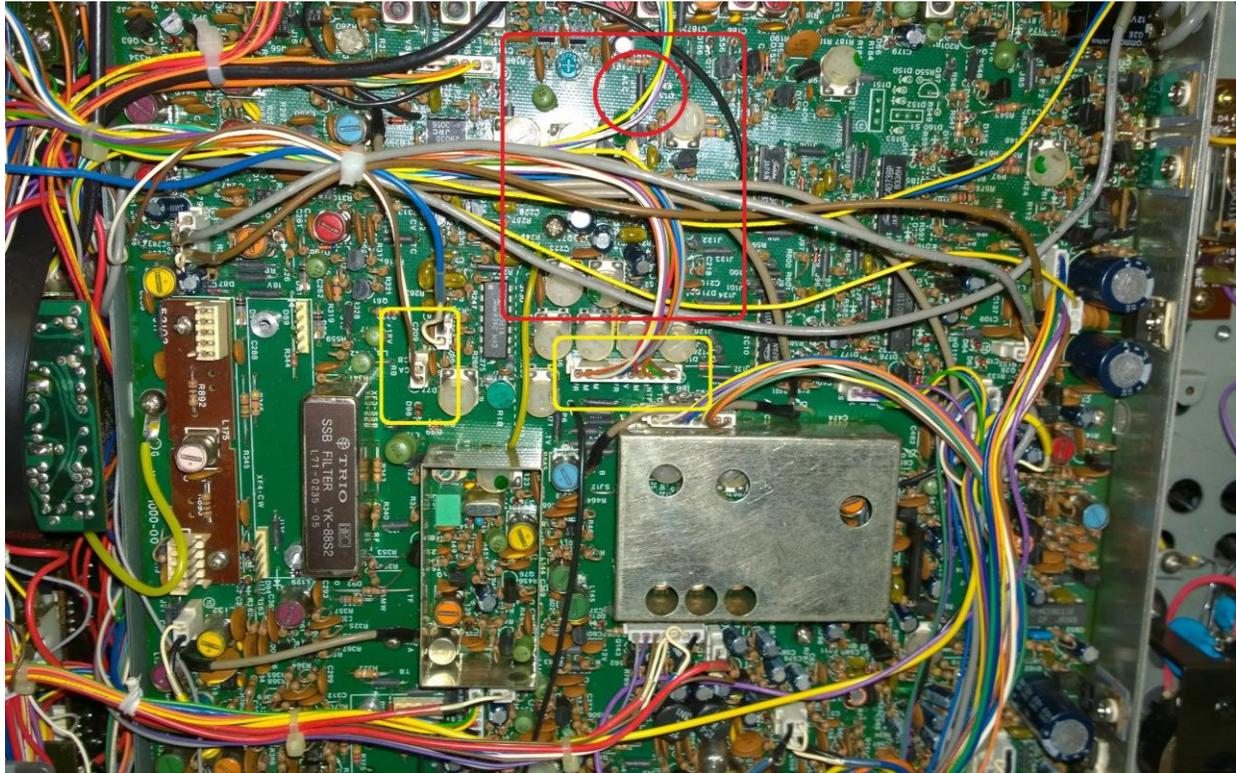
During the QSO with 9Y4D, I noticed that as the output power plummeted, the ALC went to full scale, and it could not be adjusted. The ALC level is controlled by a feedback circuit from the Power Amplifier and the LPF. The specific circuits are circled in red on the next page. The connectors are outlined in yellow. The larger one is the Automatic level Control (ALC) from the LPF. It reduces the drive from the Signal Unit to the PA as the SWR increases, and it will shut the drive down completely if it believes that the SWR is too high, there's a short at the antenna terminal or there's a fault somewhere else in the output circuit. A simple test is to remove the ALC plug from the right side of the LPF with the power off. The rig is then turned back on. With the carrier control "off" (fully counter-clockwise), the rig is set to SEND, and the carrier slowly increased. If the output power climbs to 100 watts or more as the carrier control is advanced, then the problem is in the LPF, or in the ALC circuit in the Signal Unit. Care is needed here because the power can go over 150 watts with that plug removed, which could damage the finals.

The other power control circuit is the current limiter (ICA and ICB) which comes from the connector on the AVR board. This circuit, which shuts down the drive to the PA in the event of a current overload, is maintained while rebuilding the AVR board after the Quint conversion. This circuit receives the main voltage and a slightly lower one from the voltage drop across that 0.05 ohm power resistor in the PA supply line. The gray wire from that resistor goes to the 3-pin connector on the AVR board, through one of the green inductors, and then down to the signal unit via the brown wire. The 28.5V B+ goes passes through the other green inductor down to the Signal Unit via the white wire. A simple test to see if this circuit is malfunctioning is to unplug the two-wire ICA/ICB connector (with the power off). The rig is set to SEND and the carrier control slowly eased in. If the power returns to normal, then the problem is either in the voltage output from the AVR board, or a bad component on the Signal Unit board.

Unplugging the LPF connector had no impact on the power output. Unplugging the ICA/ICB connector resulted in a slight increase in the output, but it was still under 10 watts. Voltage and signal tests indicated that there was a problem in the ALC circuit on the signal board, but it was intermittent. Full power output would return, and the ALC operation and meter indication would return to normal, usually for only a few seconds. The ALC could be “tricked” into allowing some power output by adjusting the ALC control VR13 fully clockwise, but the fact remained that there was a problem in the ALC circuit that was throttling back the signal to the PA to such a degree that the output was almost zero.

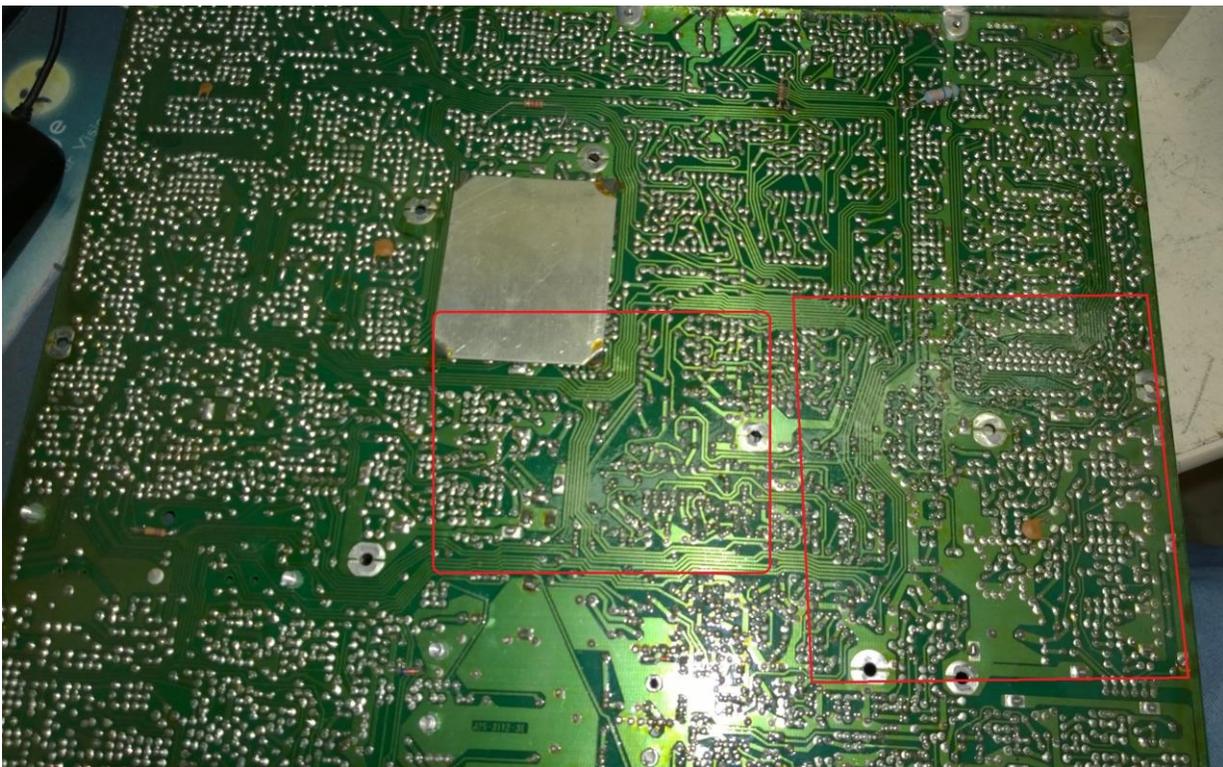
As soon as I flipped the old board over to look at the foil side, I saw the problem. The foil side had a visible white deposit on it. The deposit was particularly heavy under the ALC components.

At his point I decided to install the Signal Unit that Dave had donated months ago. It worked perfectly. Power output was spot-on, as was the ALC. The only headache was that despite the fact that it was removed from a working TS-930S, it was out of alignment with respect to this radio. While that was a bit of a hassle, it was far less of one than cleaning off the salt deposits on the original board, re-soldering the connections, reinstalling the board to see if there were any faulty components, and then possibly having to pull it back out for more testing. I’ve discovered during my various PA tests that the board connectors can only take so many plugging and unplugging cycles, so I decided to leave in the replacement board and perform the alignment.

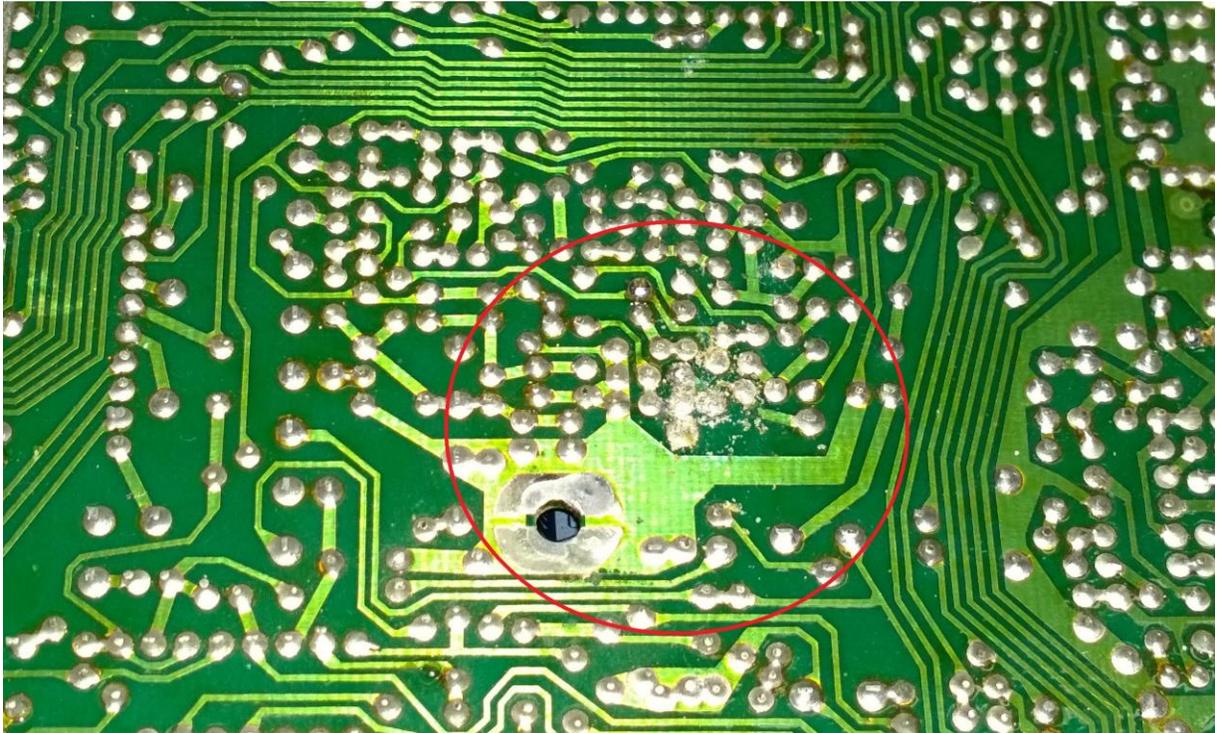
The solder joints in the corroded areas had a grainy appearance, as did some of the foil traces. When I tried to retouch some of them using a fine-grade solder, the solder refused to “take”. The flux simply bubbled up with a greenish tint. I scraped up some of the deposit for testing. Since I didn’t have an accurate PH meter here in my shack, I did what any technician or engineer would do – I tasted it. It was salty.

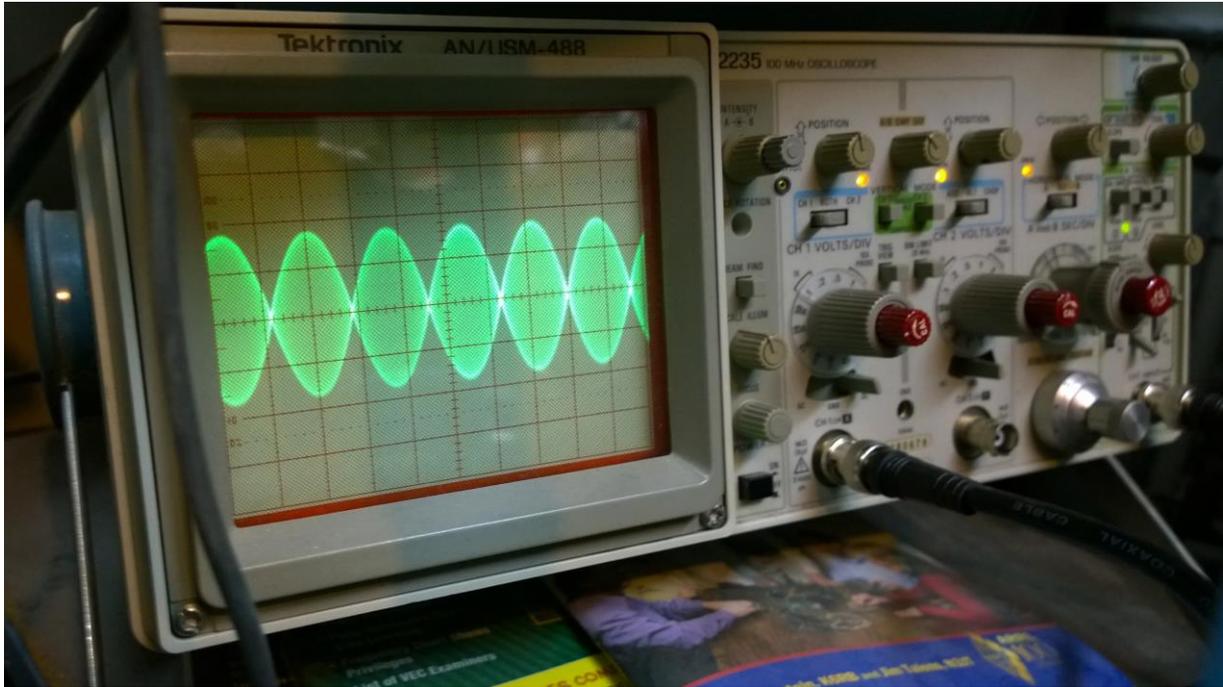
The desirable “Eggs on a Rope” waveform from the two-tone test (Dave’s description)

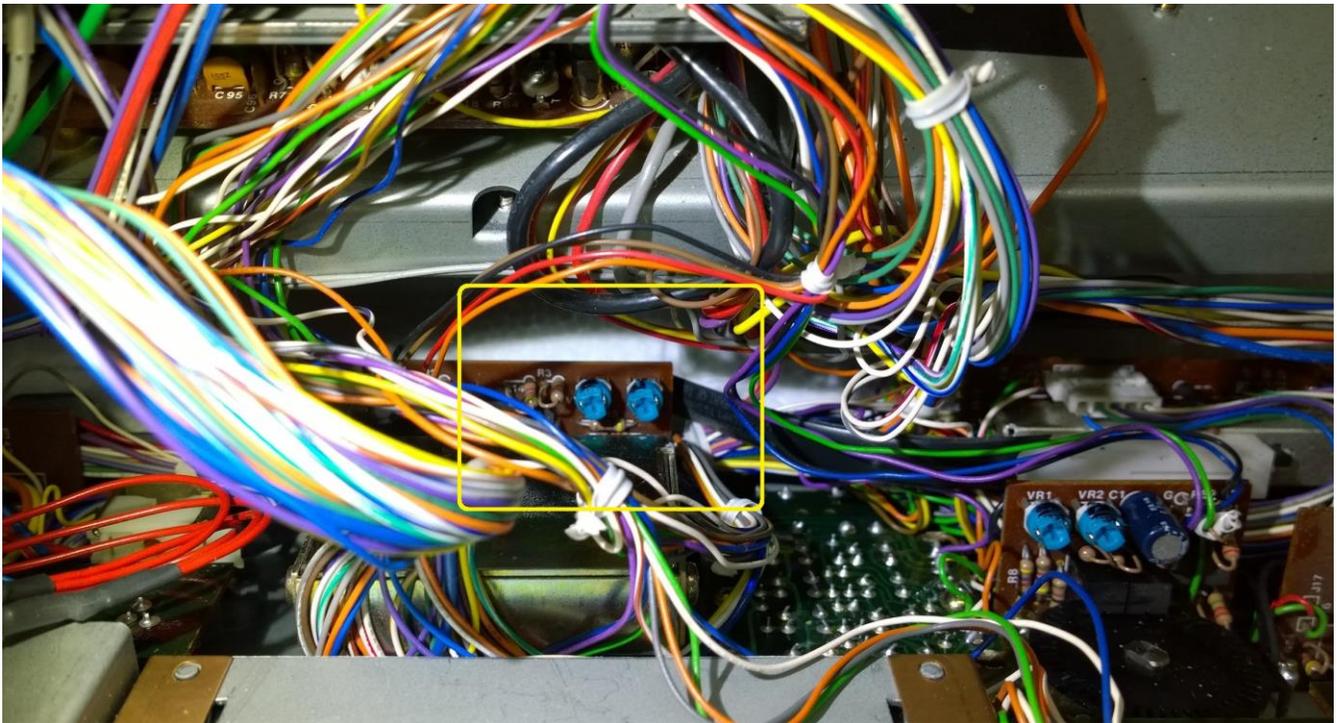
VFO: There were two problems with the VFO when I received the radio. The main tuning knob was loose. With the radio's top cover off, the VFO could be seen moving. This turned out to be a simple loose main nut behind the tuning knob. The second problem was that as the knob was turned, the readout on the display jumped around, especially the tenths and hundredths digits. This is a frequent problem with the 930S. It's caused by component drift in the VFO encoder, especially in the light output from the encoder's LED.

The easy way is to make small adjustments in the regulators until the display snaps back into proper operation. I used the easy way and it worked perfectly. I only had to move the two VR controls (outlined in yellow) about an eighth of a turn counter-clockwise to restore proper VFO operation. The black marks on the controls were put there by Kenwood. I tried clockwise first, but that made the problem worse. Some HAMS have reported that all they had to do was spray some contact cleaner into them and turn them back and forth to restore their display, but that wasn't effective. I moved both controls the same amount.

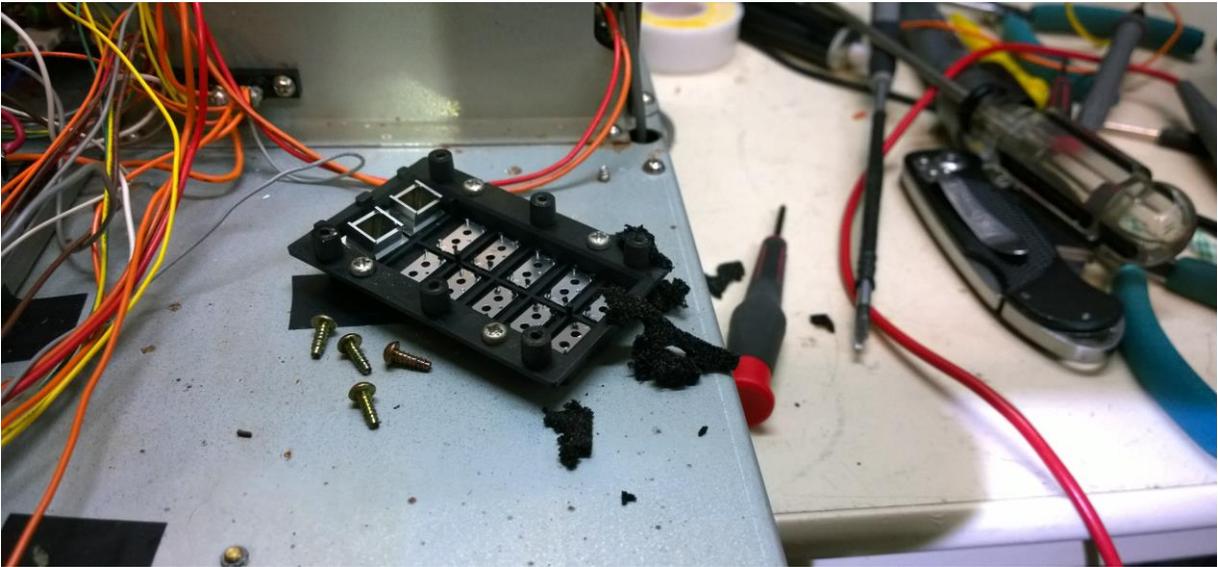
Band Switching/PLL: After restoring the VFO, I decided to tackle the band switching problem. It was logical to assume that since some of the circuit boards and controls were suffering from salt deposition and corrosion that the problem was in the push buttons. As evidence, the foam surrounding the switch assembly was completely disintegrated. While I had the front panel tilted forward, I removed the assembly and dribbled DeOxit Gold into the contacts.

The cleaning improved the action of the buttons, but the display still went blank during certain band switches. To further confuse the issue, the display only blanked when switched in one of two specific and inverted patterns. I had never experienced this before, so I wrote to Dave Phillips for advice. After thinking about it for a while, he recommended that I re-align the Phase-Locked-Loop (PLL) system, which involves the alignment procedure found on page 58 in the Service Manual. Basically, the procedure requires adjusting inter-stage transformers on the PLL board and coils on the Signal Board to achieve certain target voltage levels at the extreme ends of each band. Performing steps 1 through 7 completely eliminated the display blanking problem and resulted in crisp band changes.

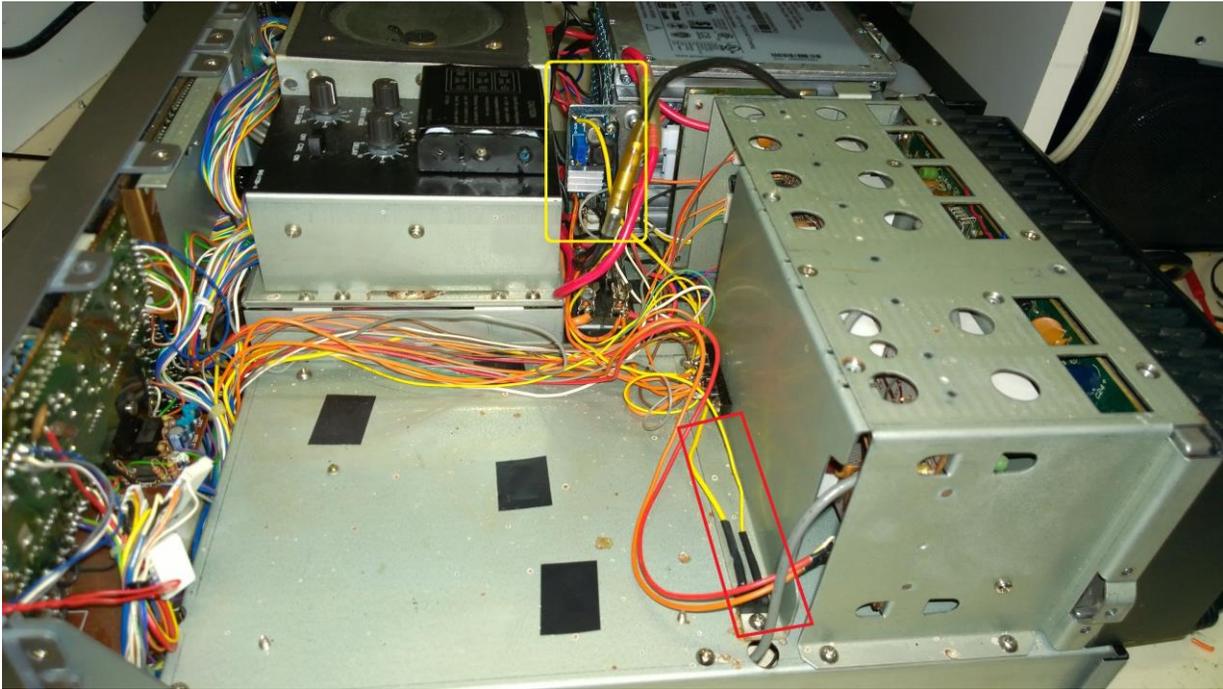
S-Meter lamps: While I had the front panel tilted forward, I measured the voltage from the DIM switch in the DIM and NOR positions. In the DIM position, the voltage dropped down slightly to 24 volts as designed, but under load, it dropped to 0.5 volts. After cleaning the switch, the problem remained, although sometimes the switch would work properly. The digital frequency readout dimmed normally. To avoid replacing the DIM switch (if one could be found) I simply installed commonly-available 12-volt “pea” lamps and drove them from an inexpensive 3-terminal 3-amp NEC regulator that I installed near the LPF. This resulted in a very pleasing, natural illumination for the S-Meter, and it will allow future lamp replacements using readily-available 12-volt pea lamps rather than the much harder to find 28-volt variety.

The 12-volt regulator can be seen in the picture on the next page, boxed in red. The item boxed in yellow is the 5-amp adjustable regulator that supplies power to the 21.7-volt sub-system.
