# Repairing the KWS-1 Plate & Ant Loading Controls

- WBear2GCR © 2018

The Collins KWS-1 Plate & Antenna loading controls frequently bind up and/or fail to run smoothly. The causes of this problem are found, discussed, and solutions presented. (more pictures still to come)

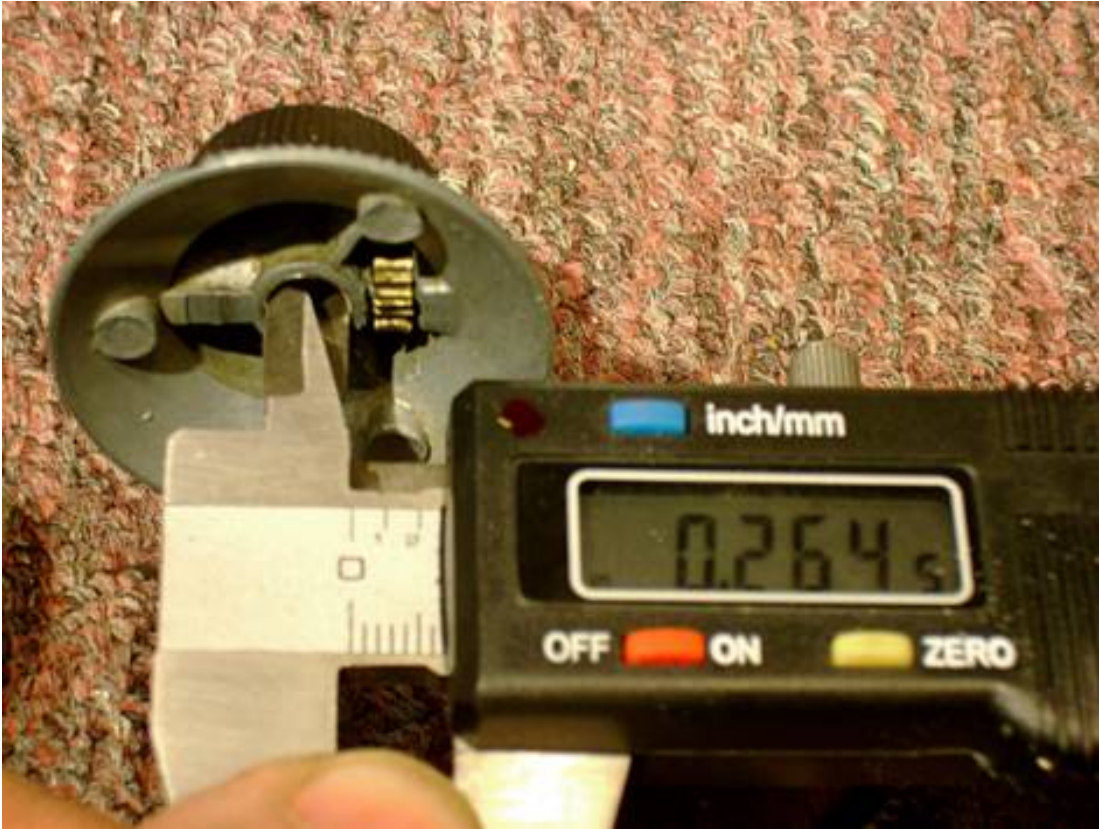
What happens is that over time the 0.250" hole in the knob that fits the stainless steel shaft becomes *elliptical*. This happens because it was made of cast *potmetal*. Potmetal is malleable (before it just breaks) and after time and under the pressure of the setscrew and use it will not keep its shape. This hole has not kept its shape.

I've measured a few. They vary a bit. One measured 0.264" in one direction (on the axis of the set screw!) and 0.254" in the other. All measured "over" by a significant amount.

The proper diameter is 0.250" plus enough extra diameter to just clear the shaft.

There are 3 1/2 possibilities.

- 1) Repair the shaft hole in the knob (best)
- 2) Shim the shaft hole.
- 3) Permanently bond the knob to the shaft and remove the knob using the set screws on the shaft coupler.

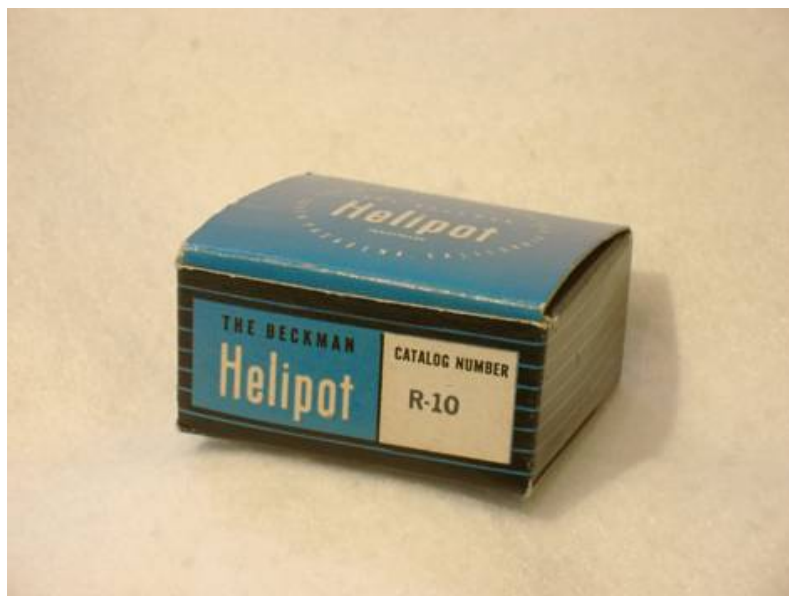
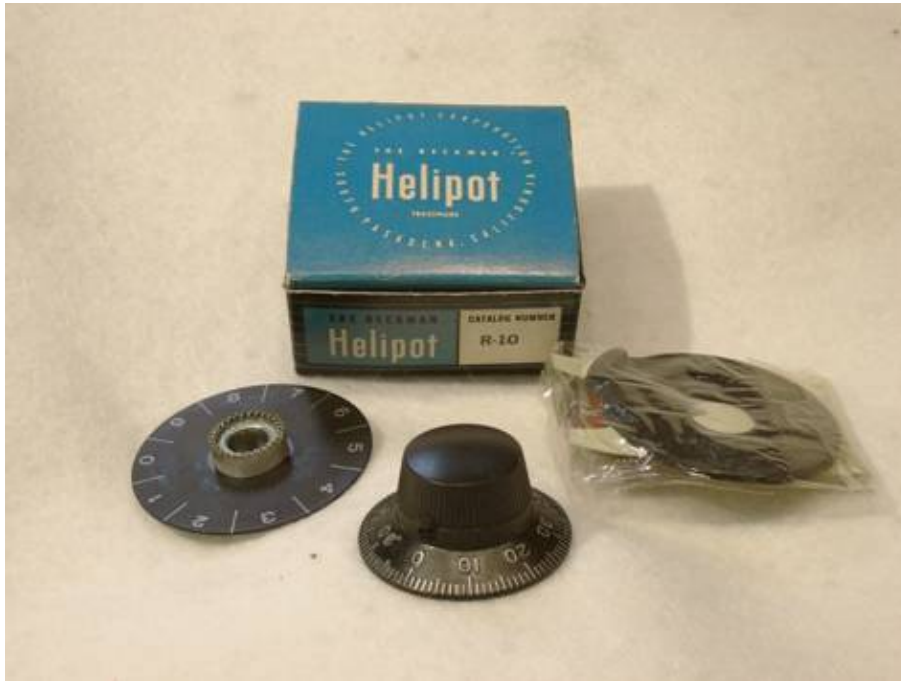
Inside the Helipot R-10 box, this is what you will find. It is similar the KWS-1 knob assembly, except the outer counter dial has a different legend printed, a different pitch to the gear and teeth, and the knob does not come with the machined & anodized knob that Collins added. There is also an installation guide.

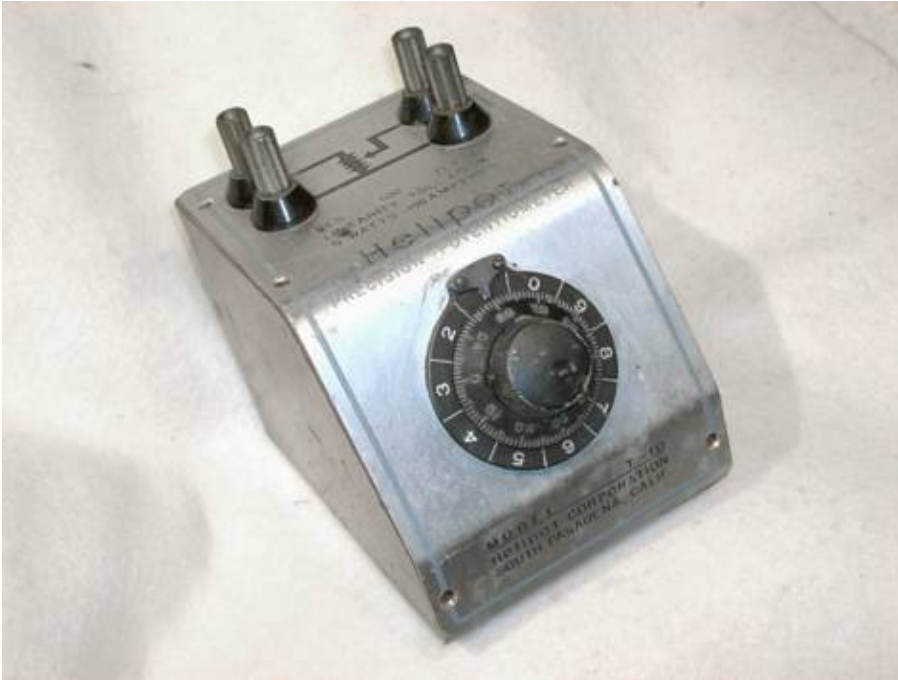
These can be found, but unfortunately this one is only 10 turns, and the KWS-1 needs 24 turns.
