Kenwood TS-930S Repair

Problems:

Primary Issue: The radio was not producing output. Specifically, it was producing very low output, on the order of 2-5 watts. The radio had previously produced full output.

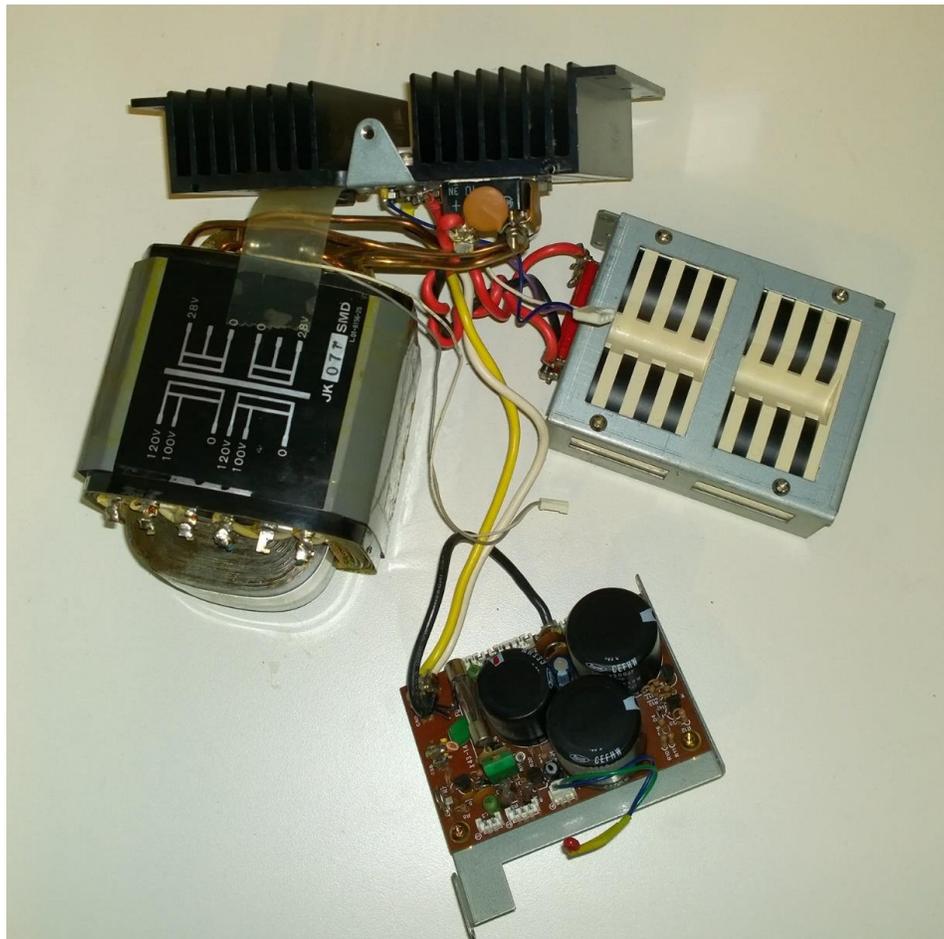
Removing the large heatsink removes the bracket for the left rear top case screw, and with the larger 776 Quint power supply in place, there's not enough room for a new bracket. As a result, that screw cannot be replaced. The top cover of the 930S will press down slightly on the Quint 776 when in place.

The only parts salvaged from the original power supply were the AVR board, and the Toshiba power transistor, insulating pad, and hardware that Kenwood uses to establish the 21.7-volt branch circuit.

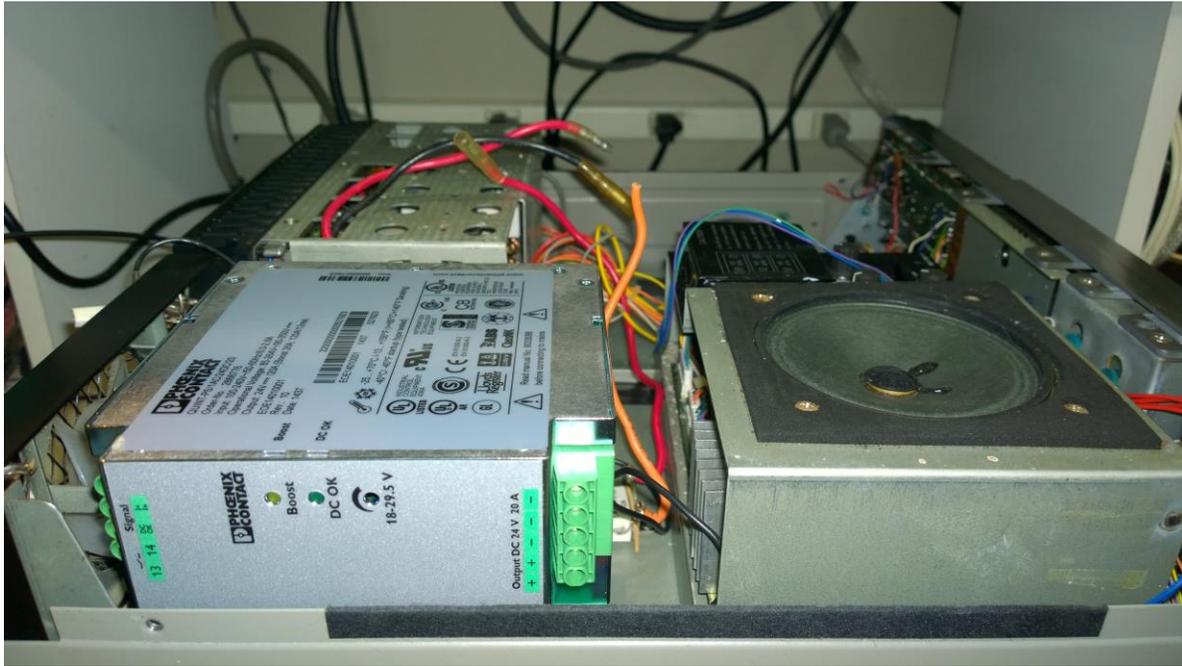
Once the AVR board was ready, it was time to install the Quint. My original plan was to re-use the Toshiba 7-ampere power transistor that Kenwood used. The 21.7-volt output is set by a Zener diode connected to the base of the Toshiba in that design. Eventually, I chose to replace this transistor with a 5-amp DC-DC converter board because it produces virtually no heat. Although the Toshiba transistor gets hot, I used that system for most of the diagnostic and testing work.

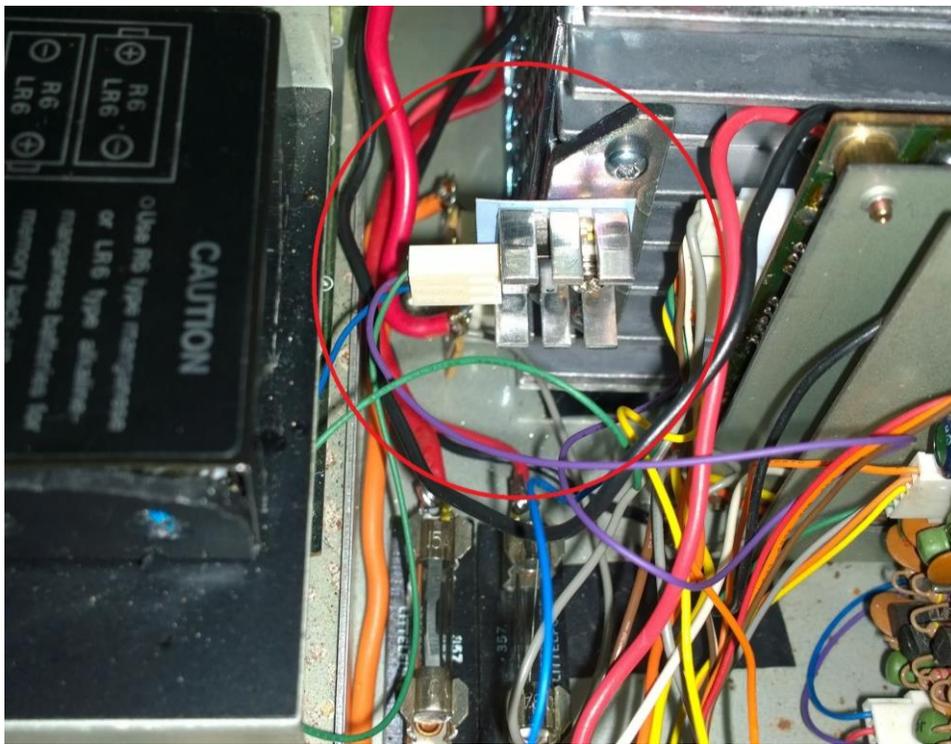
The advantage of the large 776 Quint is that the heat sink has threaded holes that were originally used for the rail mounting system. I repurposed two of them to secure the 21.7-volt branch circuit system.

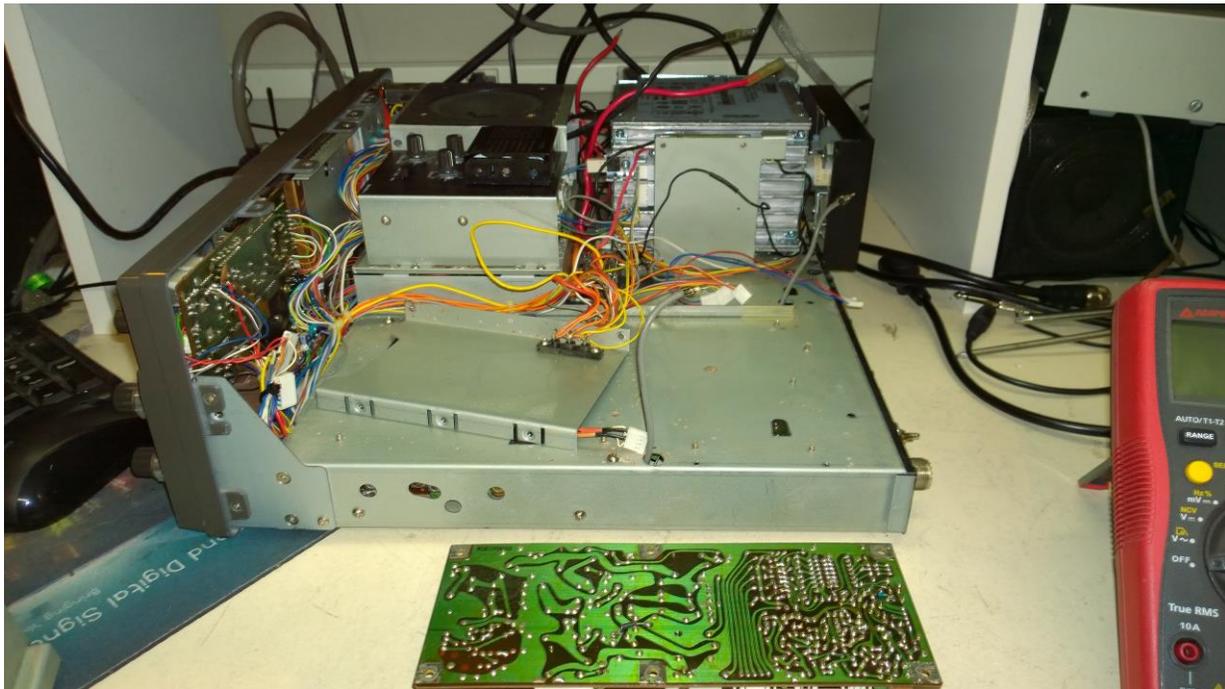
When I first removed the case to this radio, I found a fair amount of chassis rust and a grey wire underneath that had corroded and had been repaired with black vinyl tape and solder by another owner, so there was a strong possibility of a similar failure in a wire or connector between the signal board, the low-pass filter, or the power amp. This led to a complete strip down of the radio.

The board in the foreground is from the Low-Pass Filter (LPF). The LPF controls the power output of the PA through several different circuits, so a malfunction can shut down the PA.

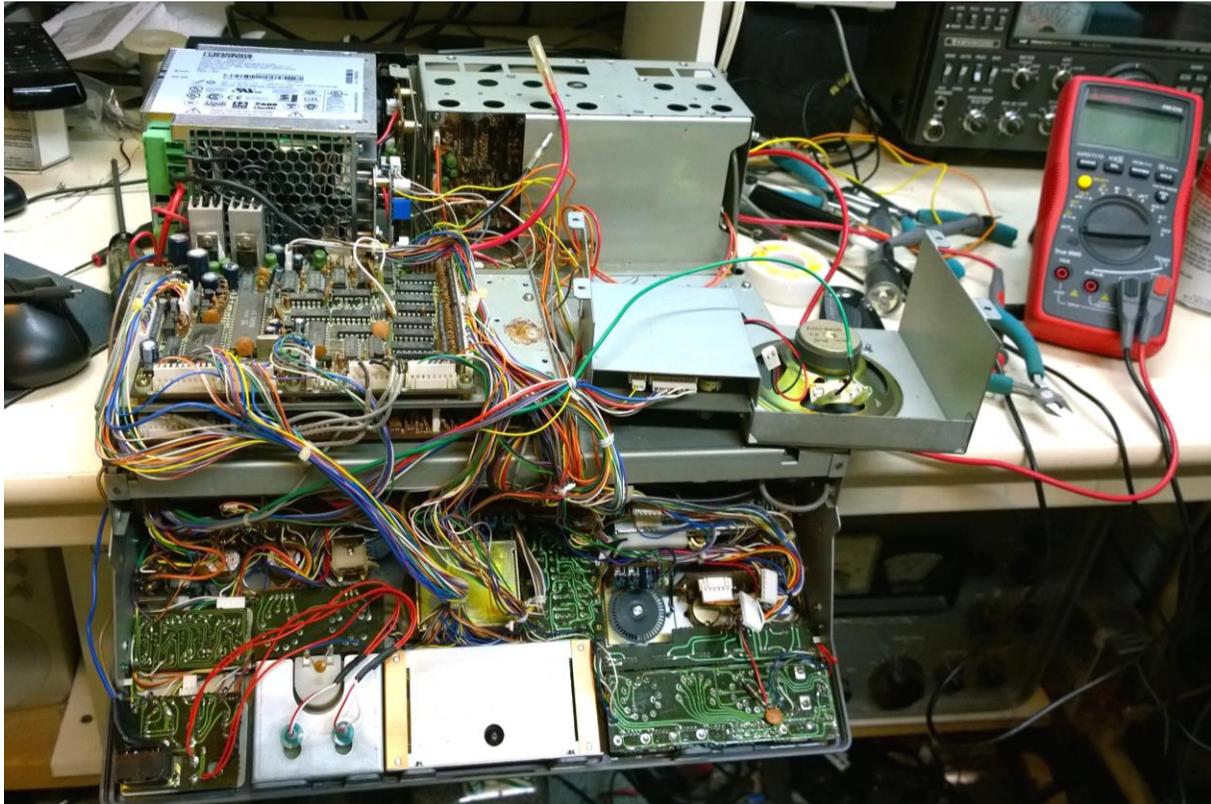
To access the circuits behind the front panel, including the VFO circuits and the band switch push buttons, I tilted down the front panel. This is easier than one might think. The advantage to this is that it's absolutely the best way to access the controls and circuits behind the panel. It's also the easiest way to change the S-meter lamps. The disadvantage is that both halves of the case must be removed.

Circuit tracing and continuity/voltage tests at the board connectors indicated that the cables and connectors were OK, so I reassembled the radio for further live testing and diagnostics.

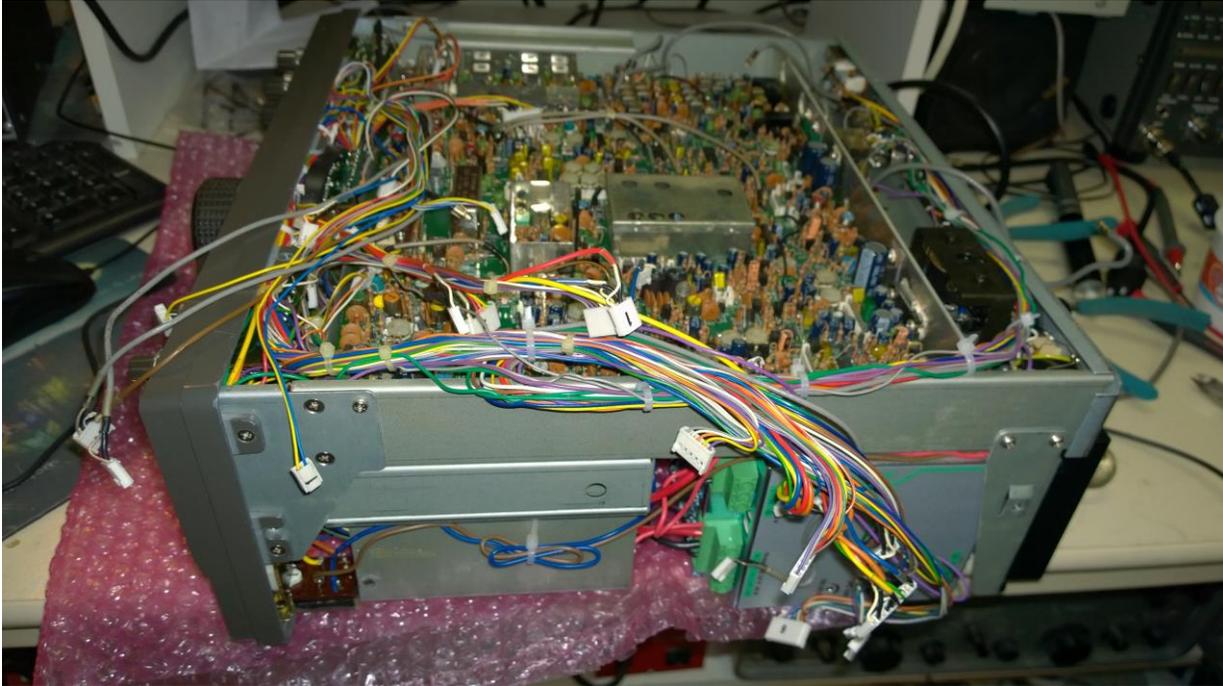
Removal of the signal unit board takes time, but it's not especially difficult. The most important thing is to take plenty of photos of the connectors and their locations. Most of the cables and connectors fall back into their places, but some have only two or three wires, and do not have "wire memory". Plugging one into the wrong board connector may cause serious damage. This is a photo of the old board coming out.

As soon as I flipped the old board over to look at the foil side, I saw the problem. The foil side had a visible white deposit on it. The deposit was particularly heavy under the ALC components.

At his point I decided to install the Signal Unit that Dave had donated months ago. It worked perfectly. Power output was spot-on, as was the ALC. The only headache was that despite the fact that it was removed from a working TS-930S, it was out of alignment with respect to this radio. While that was a bit of a hassle, it was far less of one than cleaning off the salt deposits on the original board, re-soldering the connections, reinstalling the board to see if there were any faulty components, and then possibly having to pull it back out for more testing. I’ve discovered during my various PA tests that the board connectors can only take so many plugging and unplugging cycles, so I decided to leave in the replacement board and perform the alignment.
